Manhole Inspection Summary

Manhole # S33UU_014MH

Insp Date: **4/13/07 10:48 AM**

Location Address: **2800 SAINT PAUL ST**

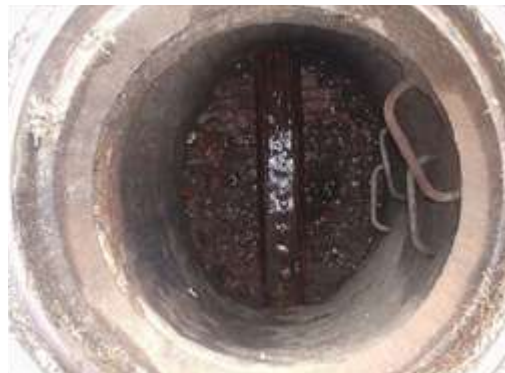
Top View

Corroded steps. Evidence of surcharge - Bench debris.

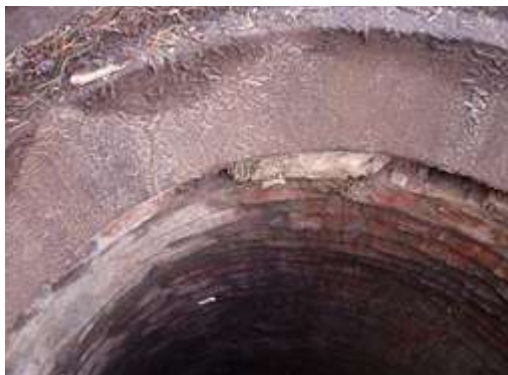
Defect

Frame leaks. Adjustment deterioration and infiltration. Corbel and Barrel infiltration - other side.

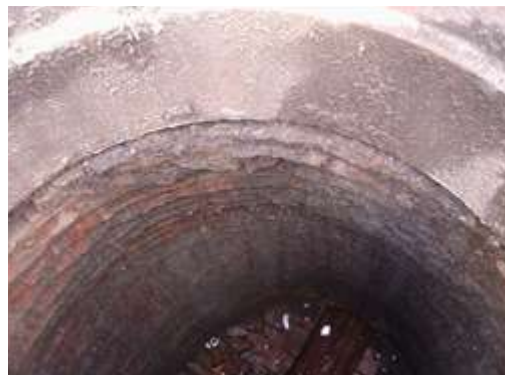
Defect

Frame leaks. Adjustment deterioration and infiltration. Corbel and Barrel infiltration.

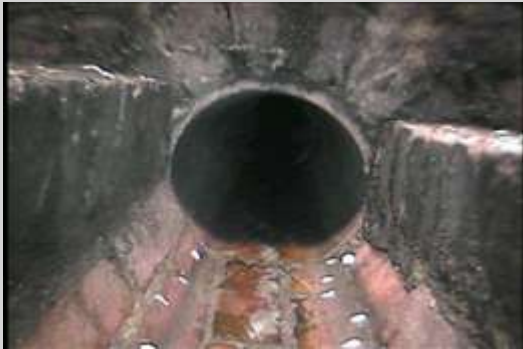
8 in. Circular Gravity Sewer Pipe Out @ 12 O'Clock

Invert Depth: **7.63** (ft.) Flow Characteristics: **Slow**

Deposits: ☒ None ☐ Mud ☐ Sludge ☐ Debris ☐ Grease

Infiltration: **None** Pipe Seal Cond: **Unknown**

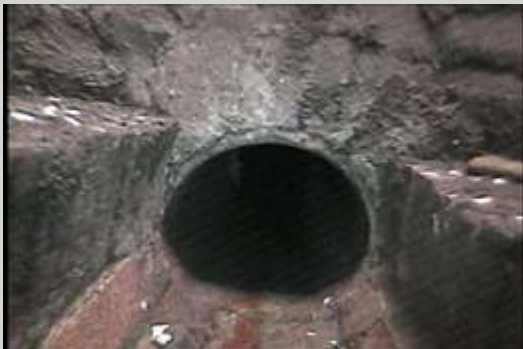
8 in. Circular Gravity Sewer Pipe In @ 6 O'Clock

Invert Depth: **7.54** (ft.) Flow Characteristics: **Slow**

Deposits: ☒ None ☐ Mud ☐ Sludge ☐ Debris ☐ Grease

Infiltration: **None** Pipe Seal Cond: **Unknown**
